Bone void filling

Clinical examples

BIO 1[®]

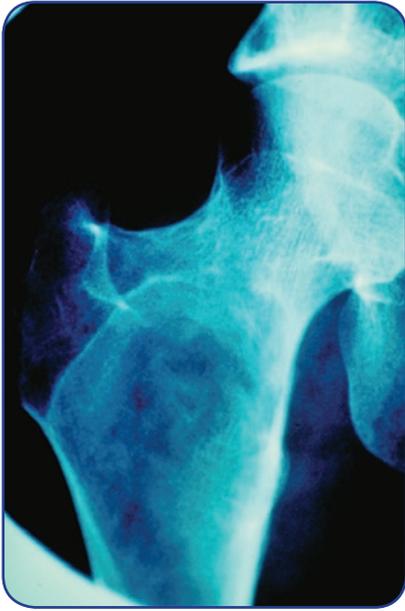
Fig 1: Pre-op X'Ray

Fig 1 : Pre-operative X'Ray.

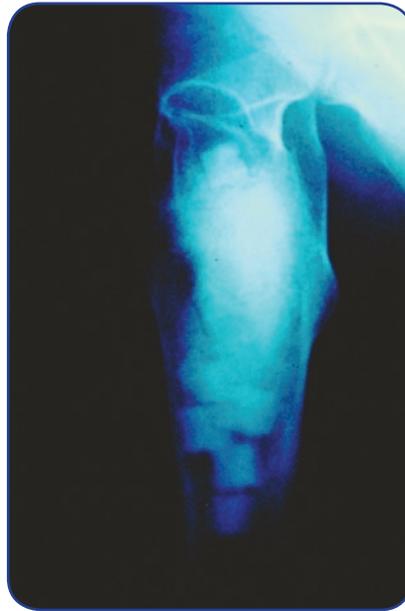
Fig 2: 3 months X'Ray

Fig 2 : 3 months post-operative X'Ray. The bone defect resulting of the cyst resection, has been filled tightly as possible with Biosorb granules and cubes, avoiding empty contact areas.

The implants were used alone, without autograft. New bone is clearly seen surrounding the implants, without any gaps, as signs of resorption are visible in the upper and lower part of the filled cavity.

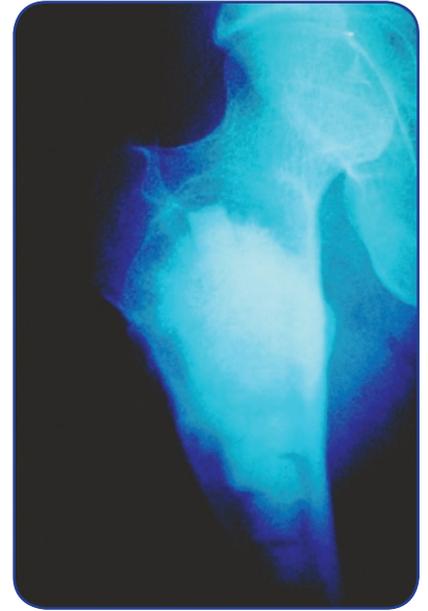
Fig 3: 6 months X'Ray

Fig 3 : 6 months post-operative X'Ray, showing a good consolidation and satisfying bone volume recovery ; the grafted areas appear more homogenous. The implants are entirely surrounded by bone and the upper and lower ones almost completely resorbed.

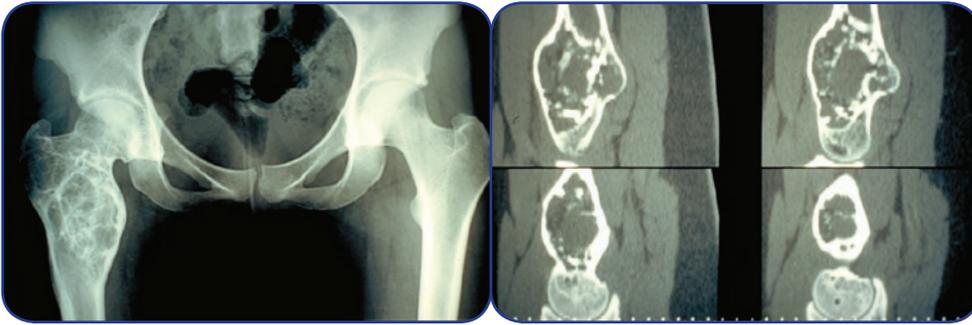
Fig 1: Pre-op X'Ray

Fig 1 & 2: Pre-operative X'Ray. We observe fissuring of the cyst on the scan.

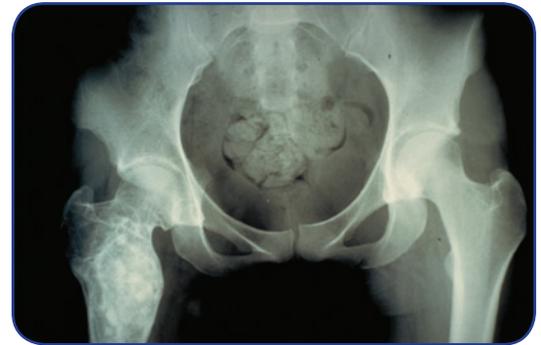
Fig 3: 1 month Post-op X'Ray

Fig 3, 4 & 5 : 1 month, 4 months and 6 months X'Rays. The radiological evolution on this period shows a progressive development of gaps between the grafts. The grafted zone appears more homogenous and shows a good bone volume recovery and a satisfying consolidation after 6 months, with a good bone density. New bone is clearly seen surrounding the implants, sign of a good resorption. After 1 year, the patient can normally walk without walking stick, and also gets back to the sports and physical activities of her school.

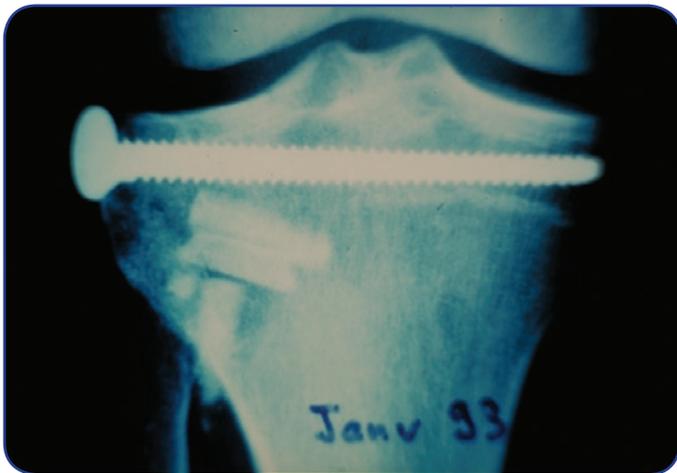
Fig 1: 3 months Post-op X'Ray

Fig 1: 3 months X-Ray after operation. The fracture was reduced and bone defect due to cancellous bone crushing filled with 45% porosity Biosorb cylinders. The patient was allowed to walk immediately after operation. The borders of the implants seem already weak and signs of the resorption appear around the upper ceramic.

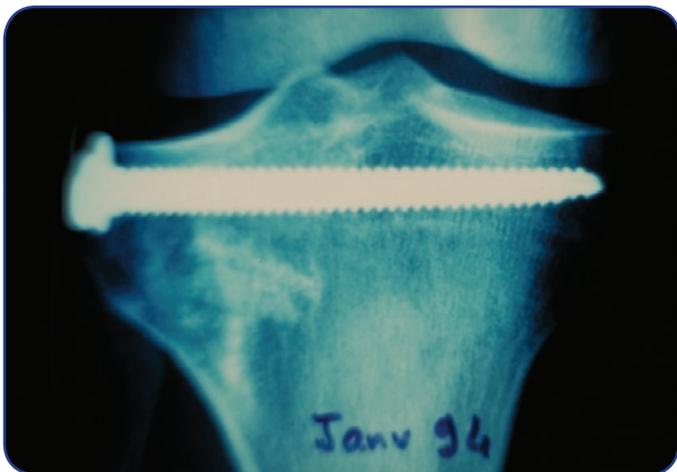
Fig 2: 15 months Post-op X'Ray

Fig 2: 15 months X'Ray after operation. The graft is almost entirely resorbed and initial bone defect restored. Bone trabeculae are visible in place of the ceramics indicating normal bone remodeling.

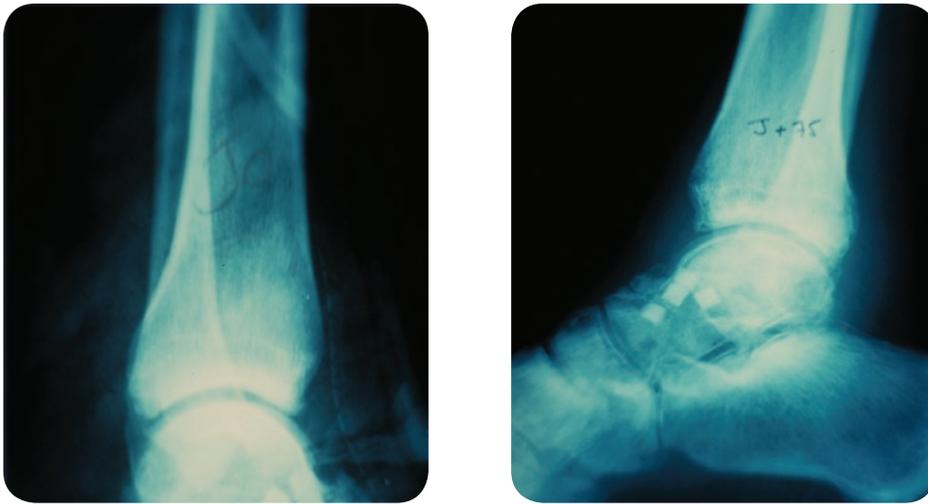
Fig 1: 2.5 months Post-op X'Ray

Fig 1: 2.5 months X-Ray after operation. In order to fill the bone defect due to the fracture and prevent risks of pseudarthrosis, Biosorb cubes were firmly inserted inside the fracture center. Tightly filling the ceramics achieved satisfying primary stability. After 2.5 months, as the plaster was removed, fracture consolidation appeared clearly, as well as a good integration of the graft.

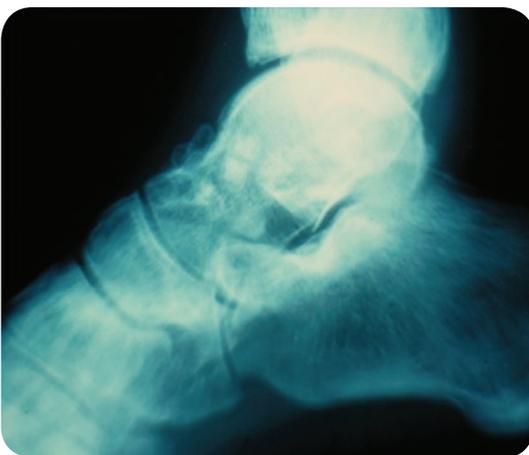
Fig 2: 8 months Post-op X'Ray

Fig 2: 8 months X-Ray after operation. A correct consolidation is obtained, as Biosorb cubes are almost entirely resorbed.

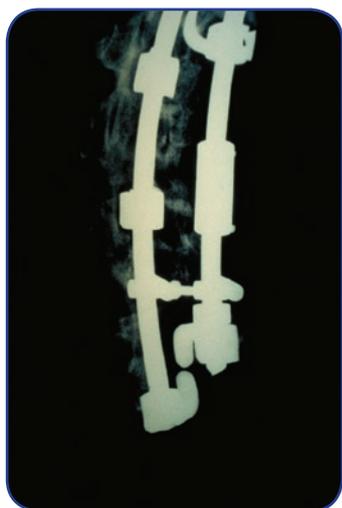
Fig 1: Post-operative X'Ray. Biosorb implants are visible.

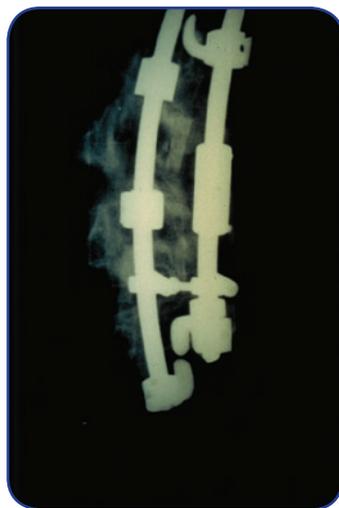
Fig 2: + 3 months

Fig 2: 3 months post-operative. The implant loses little by little its density. No secondary motion, non radioluscent line is noted.

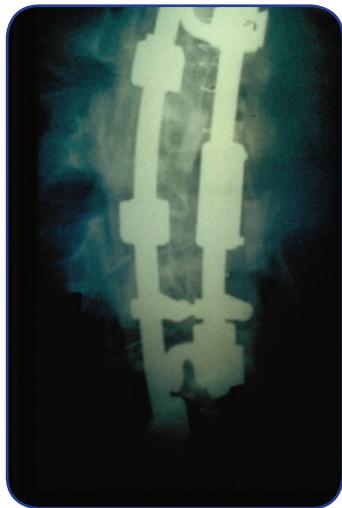
Fig 3: + 7 months

Fig 3: 7 months post-operative. The implant is almost resorbed.

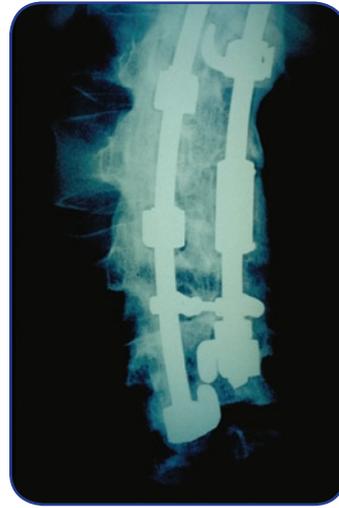
Fig 4: + 11 months

Fig 4: 11 months post-operative. The implant is totally resorbed and cannot be observed anymore.

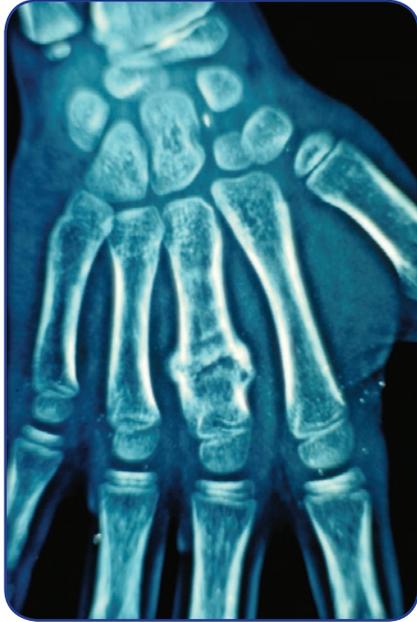
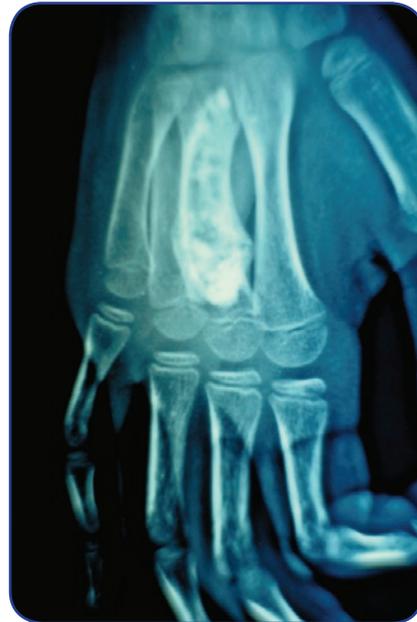
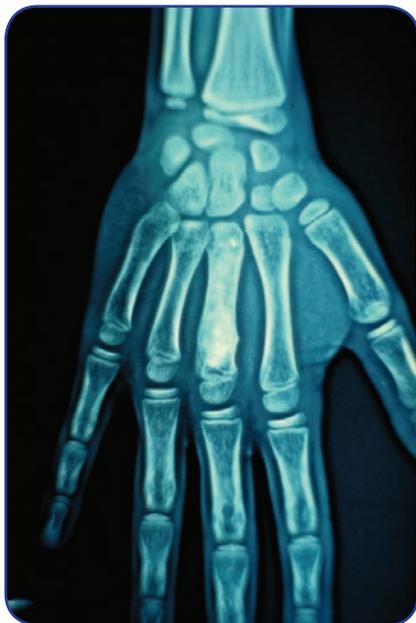
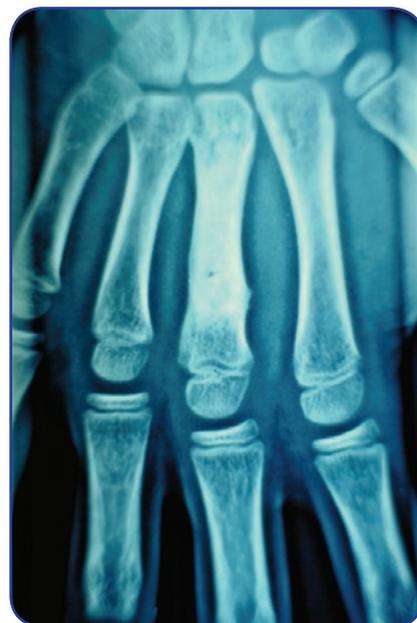
Chondroma of the metatarsus III. The bone defect due to the resection of the chondroma of the metatarsus III was filled with granules of Biosorb.

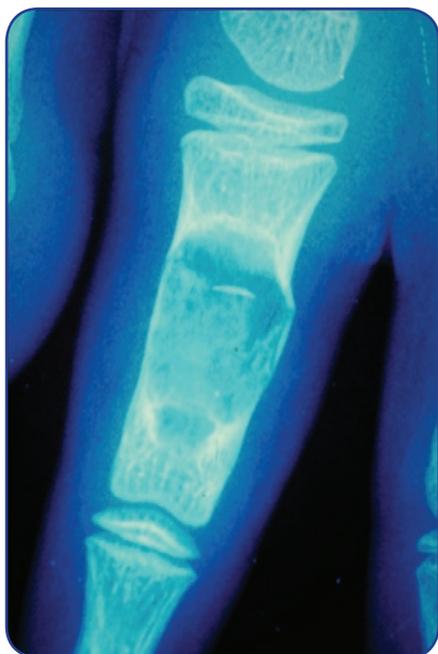
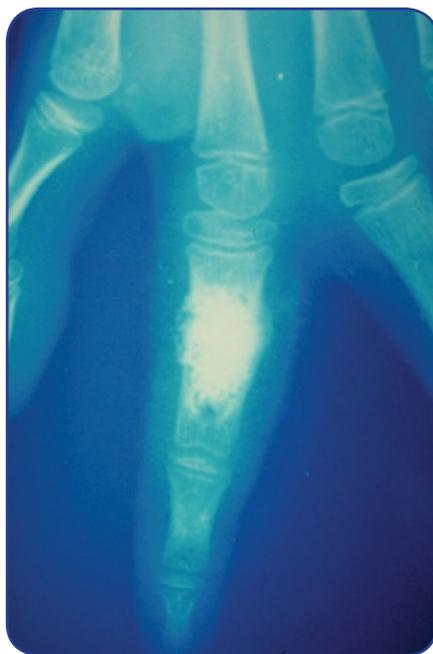
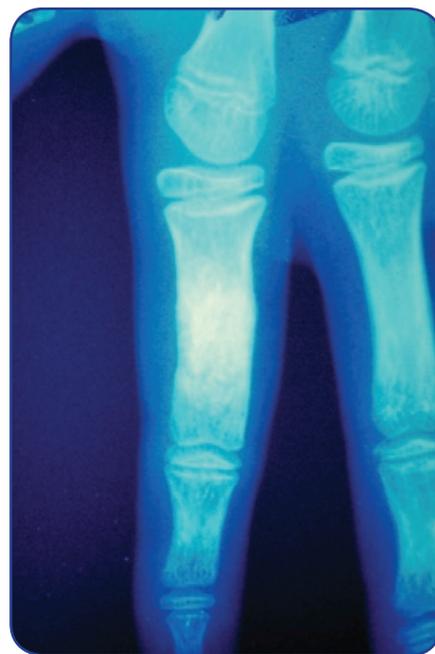
Chondroma of the proximal phalanx of the index (8 years old female)
After resection of the tumor, the bone defect was filled with granules of Biosorb.
